Manhole Inspection Summary

Manhole # S19AA2007MH

Insp Date: **11/14/06 2:11 PM**

Location Address: **1611 ROGERS AVE**

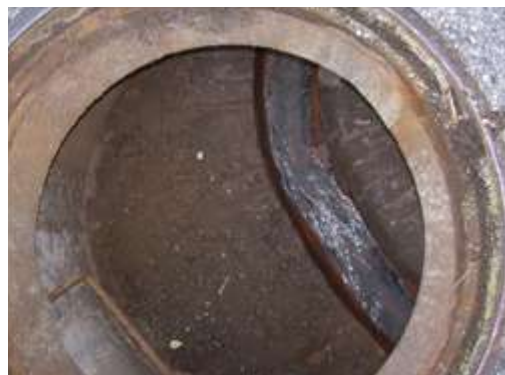
Top View

Bench ☒ Exists Material: **Brick** ☐ Parged ☒ **Debris** (not Condition related)

Steps Count: **1** Missing: **0** ☒ **Corroded**

Corroded step. Bench debris.

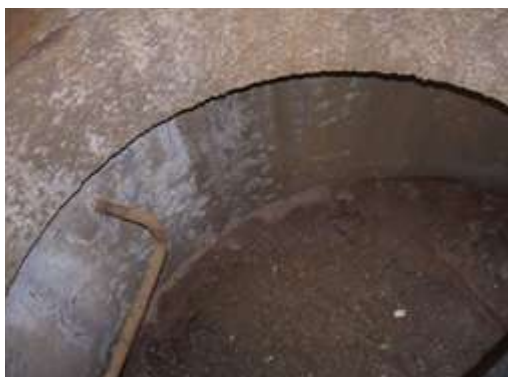
Defect

Frame Offset: **0** (in.) Condition: ☐ Sound ☐ Cracked ☒ **Leaks**

Infiltration: ☐ None ☒ **Joint** ☐ Cracks ☐ Mortar ☐ Roots ☐ Wall

Frame leaks. Corbel infiltration.

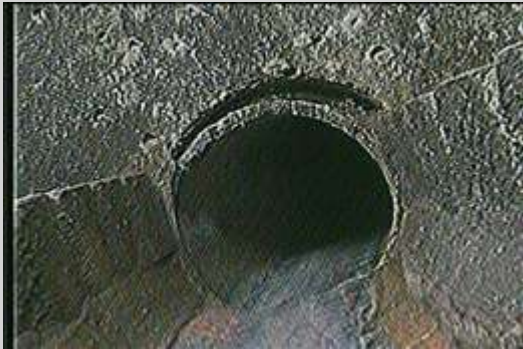
8 in. Circular Gravity Sewer Pipe Out @ 12 O'Clock

Comments **The O12 pipe seal is not flush to the pipe. The I5 pipe seal is not flush to the pipe.**

Infiltration: **Evidence** Pipe Seal Cond: **Unknown**

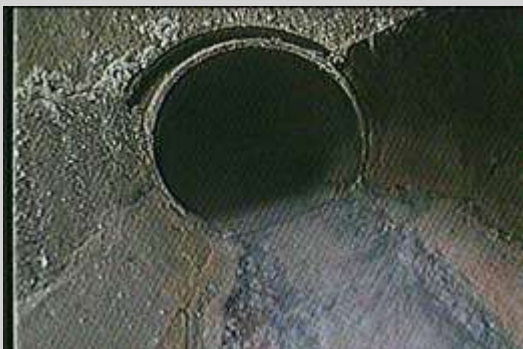
8 in. Circular Gravity Sewer Pipe In @ 5 O'Clock

Condition: ☐ Sound ☒ **Cracked** ☐ Root Intrusion ☐ Deteriorated ☐ Leaks ☐ Debris

Channel cracks.

Infiltration: **Evidence** Pipe Seal Cond: **Unknown**
